# **OPERATING EXPERIENCE WEEKLY SUMMARY**

**Office of Nuclear and Facility Safety**

**May 8 - May 14, 1998**

**Summary 98-19**

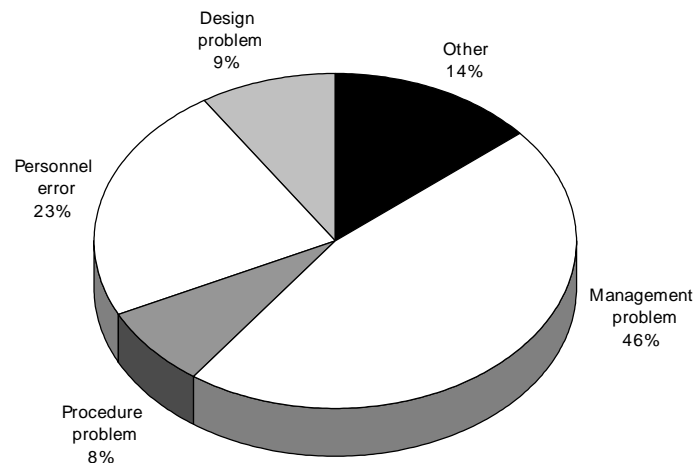
**Figure 1-1. Root Causes for Nuclear Criticality Safety Issues<sup>1</sup>**

OEAF engineers searched the ORPS database for events with a nature of occurrence of nuclear criticality safety from January 1990 to present and found 550 occurrences. Figure 1-1 shows the distribution of root causes for nuclear criticality safety issues. A review of these occurrences shows that managers reported 46 percent of the root causes as management problems and 23 percent as personnel errors. Further review of the management problems shows that 41 percent were reported as inadequate administrative control, and 24 percent were reported as policy not adequately defined, disseminated, or enforced. Further review of the personnel errors shows that 54 percent were reported as inattention to detail and 28 percent as procedure not used or used incorrectly.
